Lake Whetstone Dam Toe Drain Repair

Montgomery Co., MD

Toe drain repair at the embankment dam at Lake Whetstone in Montgomery County, Maryland.

Completion Date: January 2022

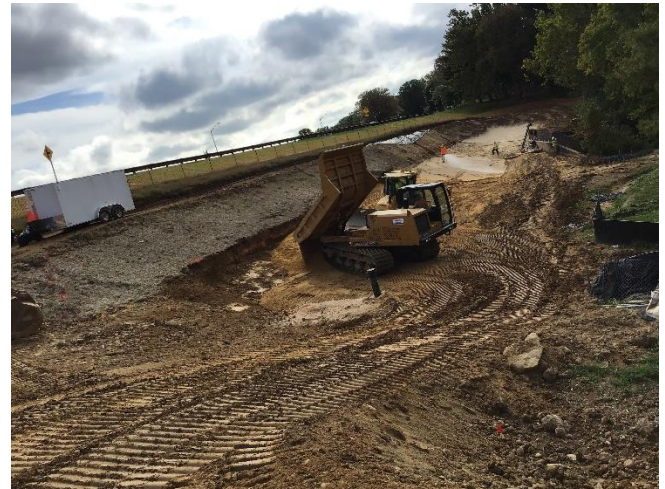
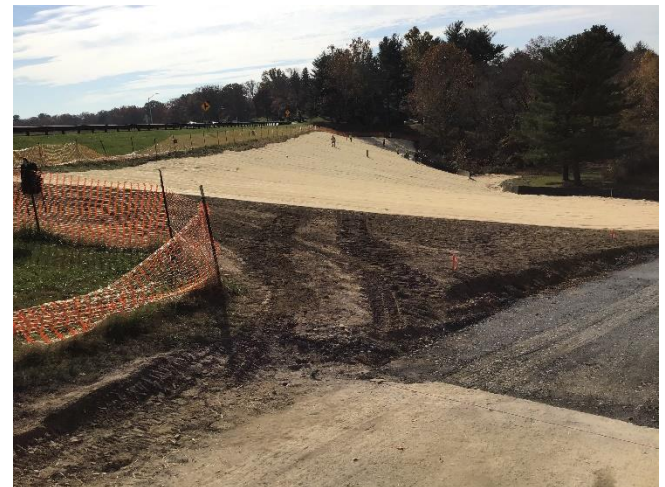
The work completed for the Montgomery County Department of Environmental Protection included the construction of a new toe drain. The 34-foot-high earth embankment dam at Lake Whetstone was constructed in 1966. It was originally constructed with a principal spillway conduit consisting of a dual box culvert. Aging and operational concerns necessitated a new toe drain replacement system construction.

The toe drain replacement project included the abandonment of the existing seepage collection drains by filling them with chemical grout as well as construction of new toe drain pipes in dual-aggregated filtered drains. Additionally, a filter diaphragm was constructed around the downstream end of the principal spillway box culvert and a blanket drain was construction on portions of the downstream slope.

New toe drain pipes were constructed in trench excavations. The new south toe drain pipe was then constructed 22” above the reported elevation of the existing 24” sewer pipe.

The entirety of the construction occurred within the footprint of the downstream slope of the dam embankment. Minor concrete repairs at the downstream headwall and within the spillway box culvert were also performed.
