# Piscataway Basin TO #43 - WSSC - Chemical Grouting and Manhole Rehab

Chemical grouting of manholes on and off-road, installation of manhole frame and covers, cementitious lining and epoxy.

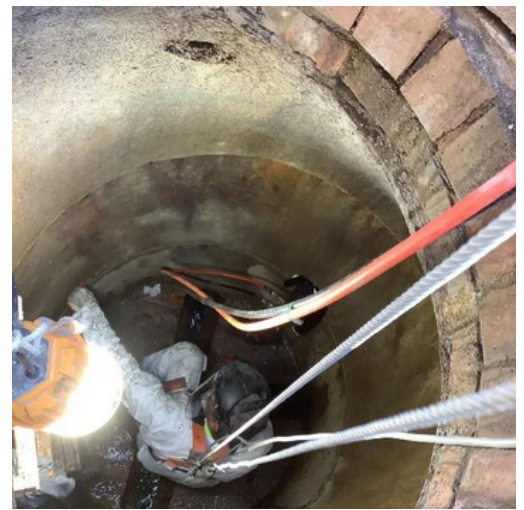
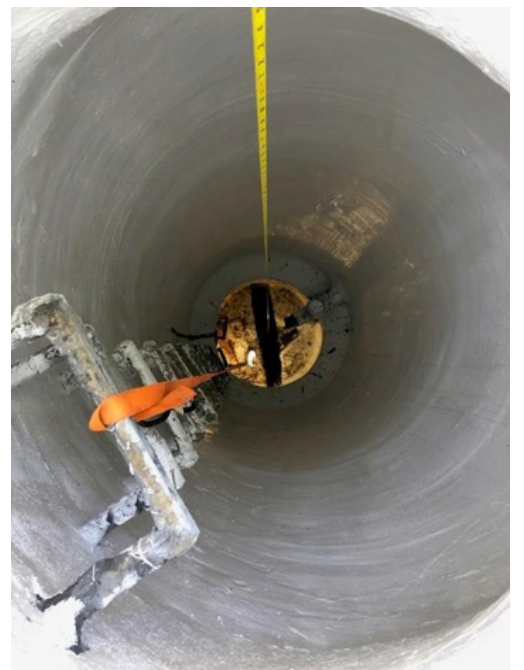
The primary purpose of this project was to stop infiltration of ground water into manholes through cracks in the aging brick manholes and concrete precast joints where rubber gaskets have failed. Over 2,000 gallons of chemical grout were pumped on this project. To apply the grout, we drilled through the manhole and pumped chemical grout behind the exterior wall of the manhole where it reacts quickly with existing ground water. This reaction creates a cured grout that is flexible and stabilizes the surrounding soil and functions as a water barrier. Also, this project has over 350 VF of cementitious lining. The cementitious lining functions to provide a water barrier and add structural integrity to the manhole. Chimney seals (75 EA) were installed on manholes throughout the project, we used a flexible epoxy that stopped infiltration and moved with the frame and cover throughout the year as temperatures fluctuate. About 75% of the work occurred on road while the rest occurred off-road, where access was limited by foot, sometimes crews had to walk 1,200 LF into the woods to complete work.
