# Lake Whetstone Dam Toe Drain Repair

Toe drain repair at the embankment dam at Lake Whetstone in Montgomery County, Maryland.

**Completion Date:** January 2022

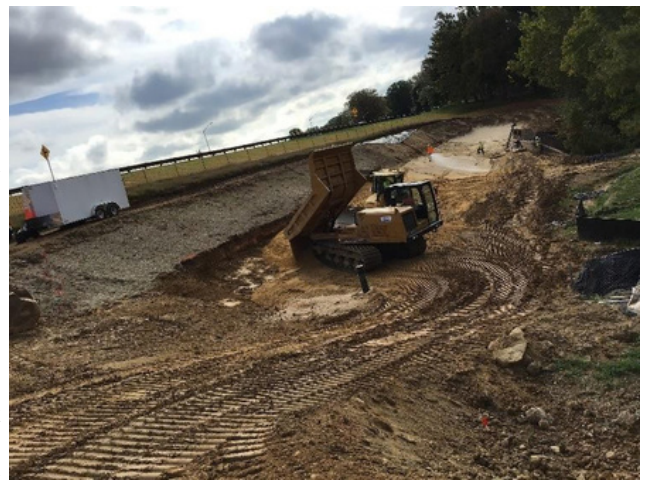
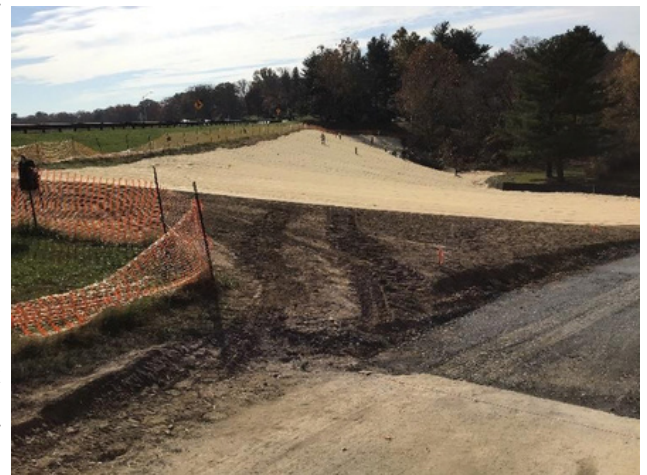
The toe drain replacement project included the abandonment of the existing seepage collection drains by filling them with chemical grout as well as construction of new toe drain pipes in dual-aggregated filtered drains. Additionally, a filter diaphragm was constructed around the downstream end of the principal spillway box culvert and a blanket drain was construction on portions of the downstream slope.

New toe drain pipes were constructed in trench excavations. The new south toe drain pipe was then constructed 22" above the reported elevation of the existing 24" sewer pipe.

The entirety of the construction occurred within the footprint of the downstream slope of the dam embankment. Minor concrete repairs at the downstream headwall and within the spillway box culvert were also performed.
